SOIL SURVEY REPORT

AVONLIE SOLAR FARM

March 2018

Report identification: 5034 - Avonlie

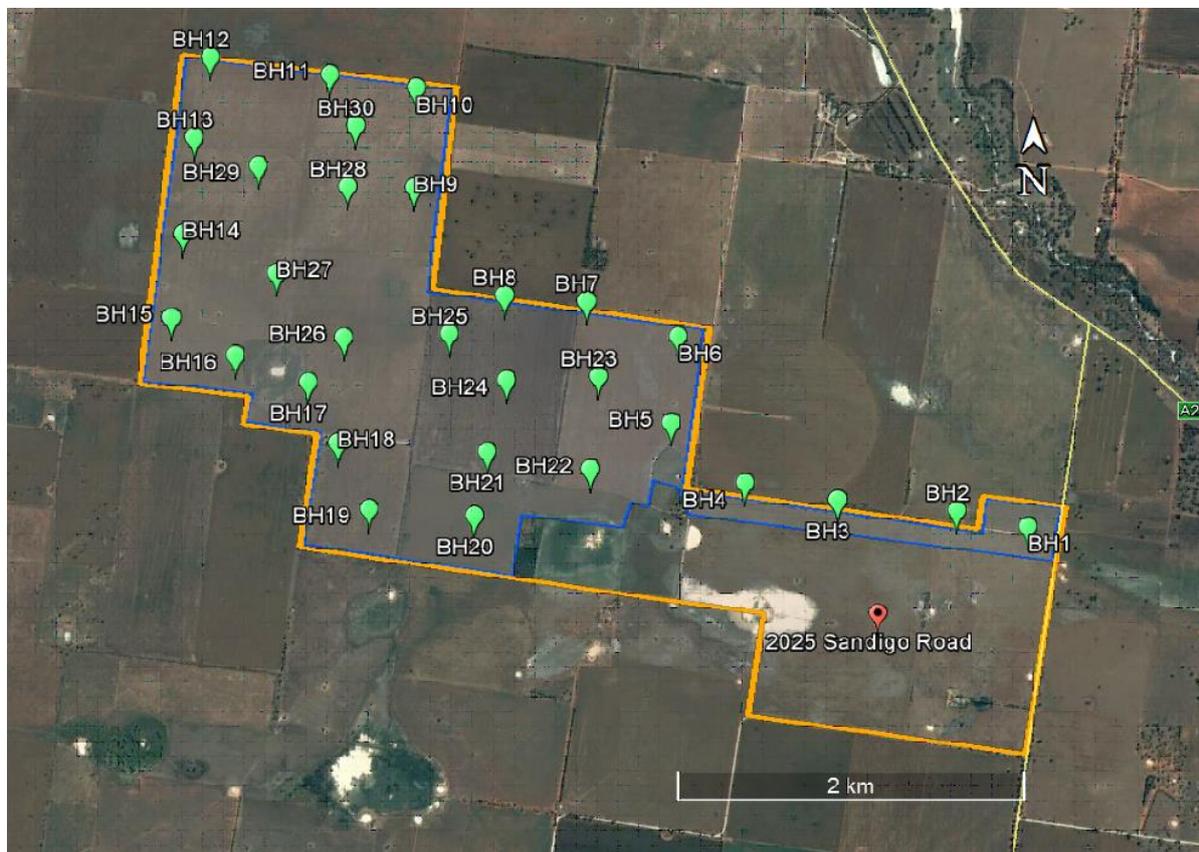
Figure 1: Soil Survey Core Locations

As follows is a map of the investigated site and approximate investigation pit locations, Figure 1.

A free soil survey was conducted using standard soil surveying techniques. Sampling and classification of in situ soils was carried out as per the Australian Soil and Land Survey Field Handbook (2009) and The Australian Soil Classification (Isbell, 1996). Density of investigation pits was determined via Guidelines for Surveying Soil and Land Resources (2008) where selection of a 'Moderately High (Detailed)' intensity level was deemed appropriate for satisfying the objectives for detailed project planning. Soils encountered were typical of the locale, generally falling into reconnaissance survey classes. Slight variations in profiles exist due to remnant channels and the complex soil sequences that are associated with such. Soil moisture contents varied considerably between soil types but were generally found to be moderately moist to wet at depth. Free groundwater was not encountered to the investigated depths.

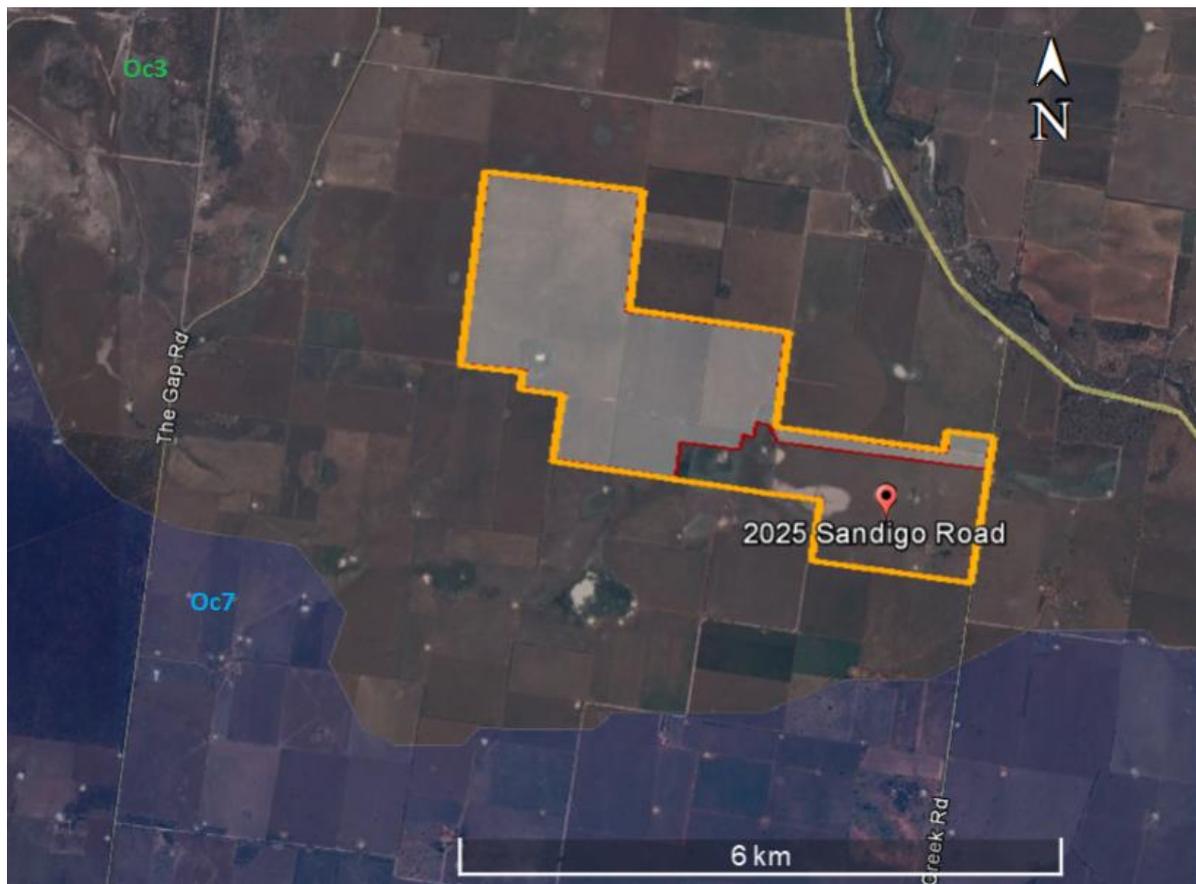
Figure 2: Mapping Units of the Digital Atlas of Australian Soils with Site Overlay.

As follows are the soil mapping units of the Digital Atlas of Australian Soils (1991) that has been generally validated by the soil survey through laboratory and field techniques with soils across the majority of the site being Chromosol with Sodosols to the south, Figure 2. As such, management practices can be grouped into management classes of either soil mapping units or Australian Soil Classification (ASC) units. This report identifies management practices for equivalent ASC units in section 6.5 below.

The site and nearby surrounds lies within the mapping units **Oc3** and **Oc7** from the Digital Atlas of Australian Soils (CSIRO, 1991).

The map unit **Oc3** is described as:

"Plains with domes, lunettes, and swampy depressions, and divided by continuous or discontinuous low river ridges associated with prior stream systems--the whole traversed by present stream valleys; layered soil or sedimentary materials common at fairly shallow depths: chief soils are hard alkaline red soils (Dr2.33), grey and brown cracking clays, commonly (Ug5.24) and (Ug5.35), and other (D) soils in a complex soil pattern with the following general features: (i) well-drained to moderately drained plains of (Dr2.33) with (Db1.33 and Db1.43), often with thin A horizons (<4 in. thick); (ii) moderately to poorly drained gilgai plains subject to some seasonal flooding of (Ug5.3), (Dr2.33), (Db1.43), (Dy2.33 and Dy2.43), and (Ug5.2) soils; (iii) poorly drained gilgai plains subject to frequent seasonal flooding of (Ug5.2), (Ug5.3), (Db1.43), (Dy2.43), (Dd1.33 and Dd1.43), and (Ug5.4) soils; (iv) swampy depressions of (Dd1.33 and Dd1.43), (Db1.43), (Dy2.43), (Dy3.43), and (Ug5) soils; (v) domes and/or lu.

The map unit **Oc7** is described as:

"Undulating country with broad slopes and low, narrow, often gravelly or stony ridges: chief soils are hard alkaline red soils (Dr2.33) throughout the undulating terrain. Associated are: red earths (Gn2.12 and Gn2.13), sometimes with clay D horizons, in depositional sites; gravelly or stony ridges of hard neutral red soils (Dr2.32 and Dr2.42) and shallow loams (Um4.1) similar to unit Qc3; and small gilgai areas with some cracking clays (Ug5.2 and Ug5.3). Data are limited. Occurs on sheet(s): 3"
